5.19 HAZARDOUS WASTE IMPACTS

5.19.5.3 Phase III ESA for NBD Bank Site (Northwest Acquisition Area)

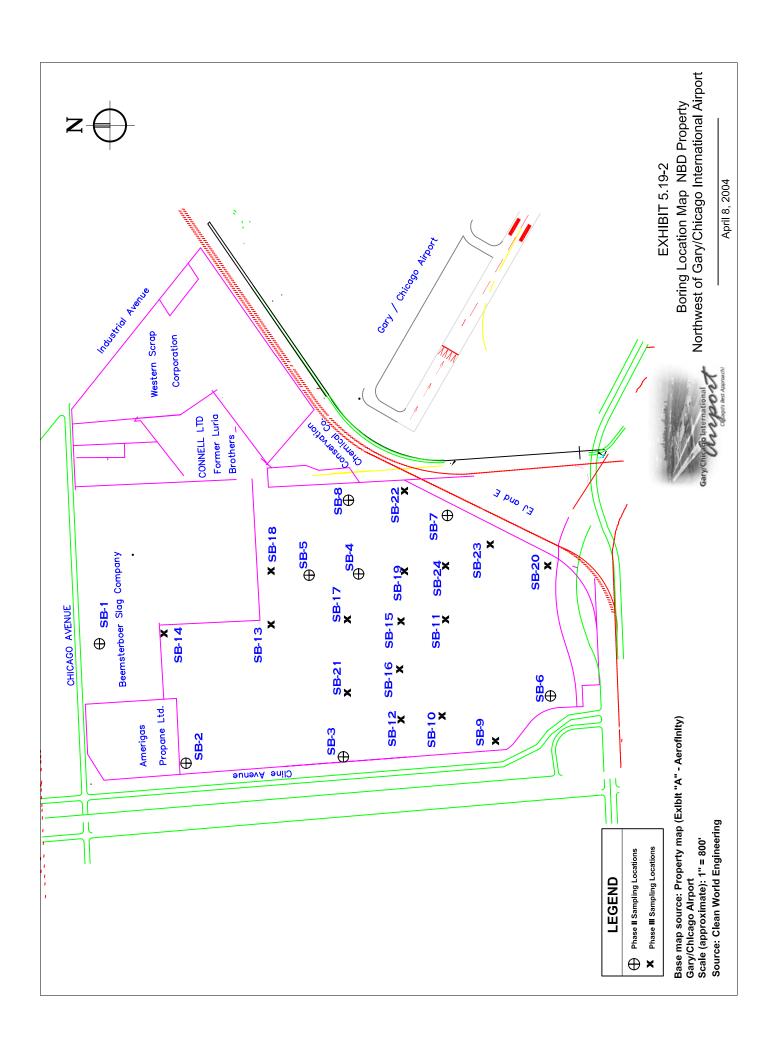
During the October 2002 investigation, eight soil borings (SB-1 through SB-8 on **Exhibit 5.19-2**) were installed using a hollow stem auger until groundwater was encountered. Continuous sampling was performed at 2-foot intervals with a split-spoon sampler. Surface and subsurface

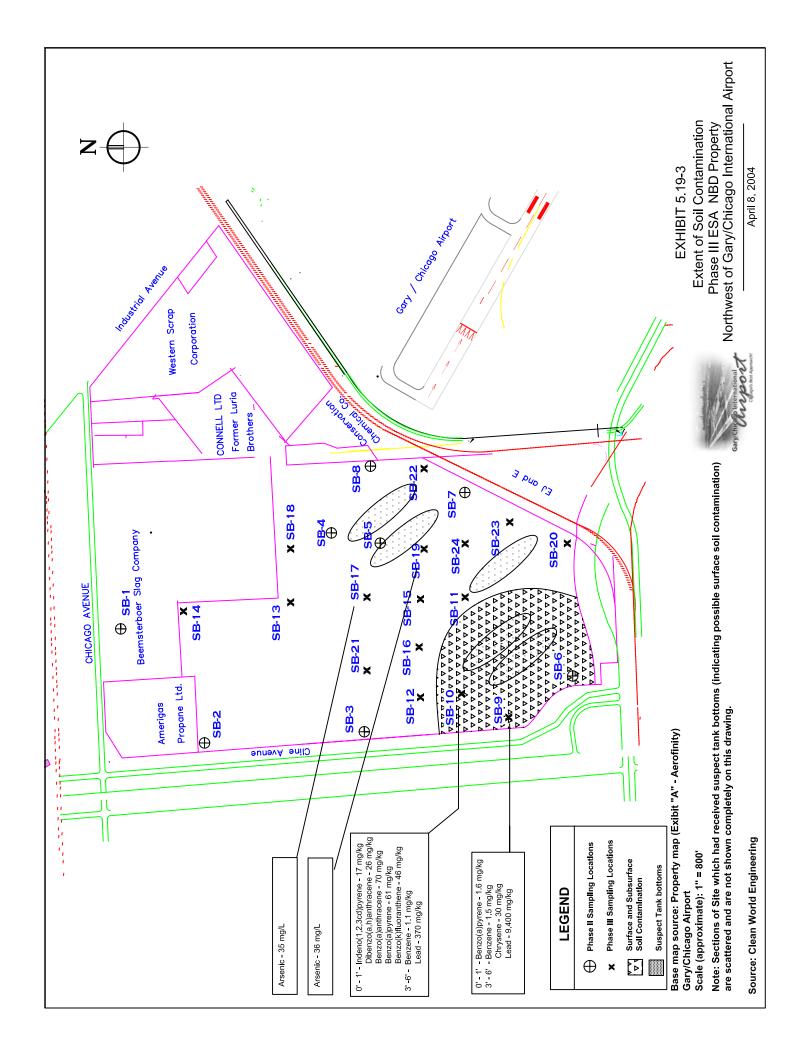
- Site surface soil is contaminated at the area of suspect tank bottoms, and at the southwest corner of the site (SB-9 and SB-10). The extent of subsurface soil contamination has been limited to the southwest portion (SB-9 and SB-10) of the NBD Bank Trust Property, as shown in **Exhibit 5.19-3**.

- The benzene concentrations for subsurface samples SB-9-SS and SB-10-SS exceeded
 the RISC migration to groundwater closure levels for industrial land use. Other VOCs in
 subsurface soil samples detected above the reporting limits were below the IDEM RISC
 industrial closure levels.

- The PNAs benzo(a)pyrene in surface soil sample SB-9-S, and benzo(a)anthracene, benzo(a)pyrene, benzo(b)fluoranthene, dibenz(a,h)anthracene, and indeno(1,2,3cd)pyrene in surface soil sample SB-10-S were detected above the IDEM RISC industrial direct contact level.

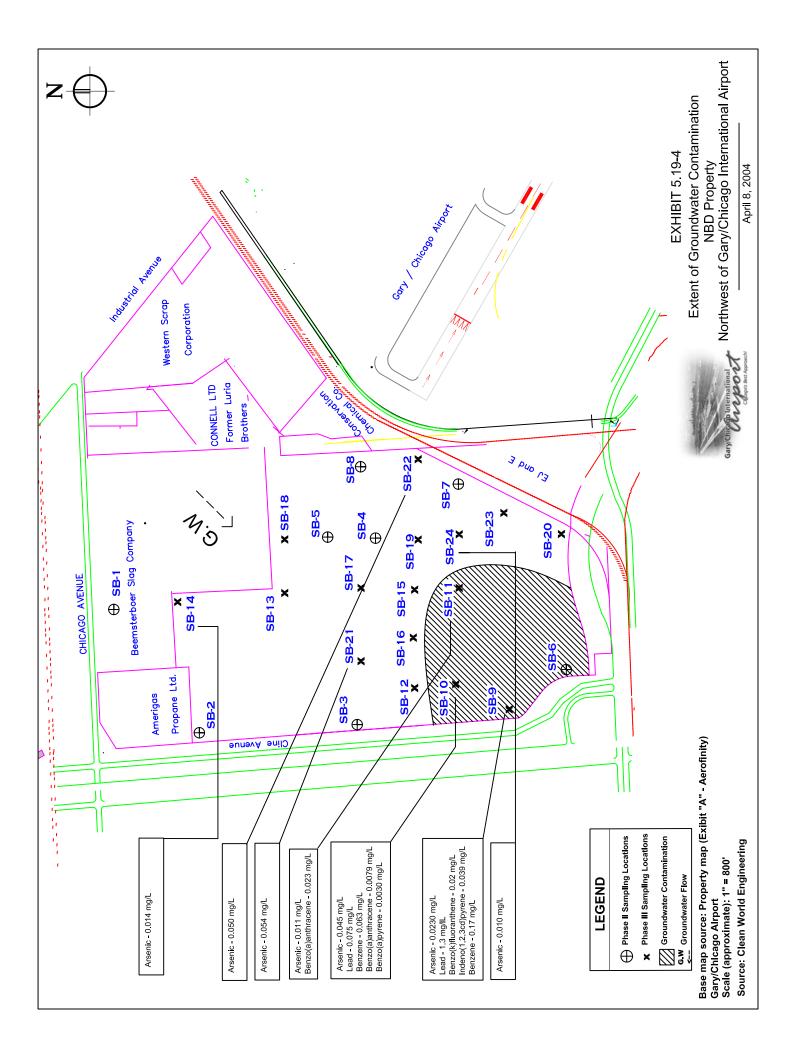
- Groundwater beneath the NBD Bank Trust Property has possibly been impacted from both on and off-site sources. Groundwater is contaminated in the southwest portion of the NBD Bank Trust Property (SB-9, SB-10, and SB-11). The extent of groundwater contamination has been limited to the southwest portion of the NBD Bank Trust Property, as shown on Exhibit 5.19-4.

- The VOC benzene in groundwater sample SB-9-W was detected above the IDEM RISC groundwater closure level for residential and industrial land use. VOC benzene in groundwater sample SB-10-W was detected above the IDEM RISC groundwater closure level for residential land use. Other VOCs in groundwater samples detected above the laboratory-reporting limits were all below the IDEM RISC groundwater closure level for residential land use.

- The PNAs indeno(1,2,3cd)pyrene in groundwater sample SB-9-W; benzo(a)anthracene in groundwater samples SB-10-W and SB-11-W; and benzo(a)pyrene in ground sample SB-10-W were detected above the IDEM RISC closure levels for residential and industrial land use. The PNA benzo(k)fluoranthene in groundwater sample SB-9-W was detected above the IDEM RISC closure level for residential land use. Other PNAs in groundwater samples detected above the laboratory-reporting limits were all below the IDEM RISC groundwater closure level for residential land use.
